Appendix D Crash Analysis

W. Ogden Avenue Crashes

S. Pulaski Rd. to S. Kedzie Ave. | 2017-2021

Ogden Avenue Fatal and Serious Injury Crashes Pulaski to Kedzie 2017-2021

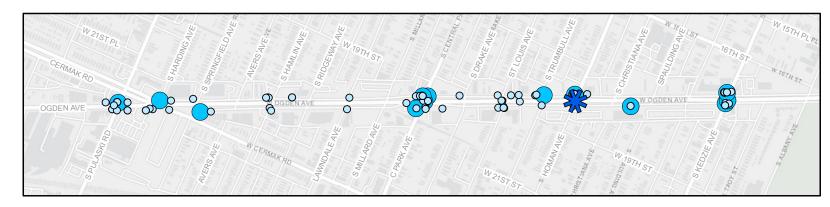
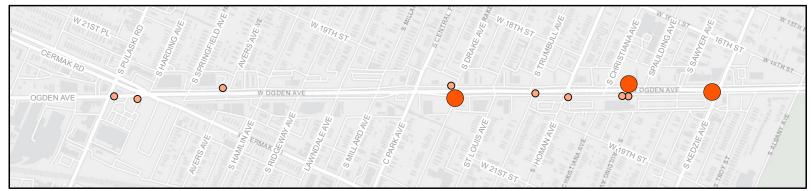
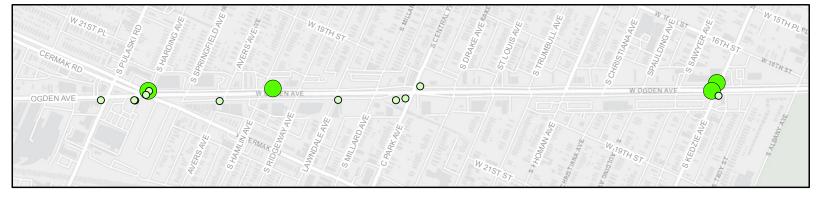
Fatal Auto Crash

A-Injury Auto Crash

B-Injury Auto Crash

- A-Injury Bicyclist Crash
- B-Injury Bicyclist Crash

- A-Injury Pedestrian Crash
- o B-Injury Pedestrian Crash
