# Appendix E

# Corridor Photo Exhibits

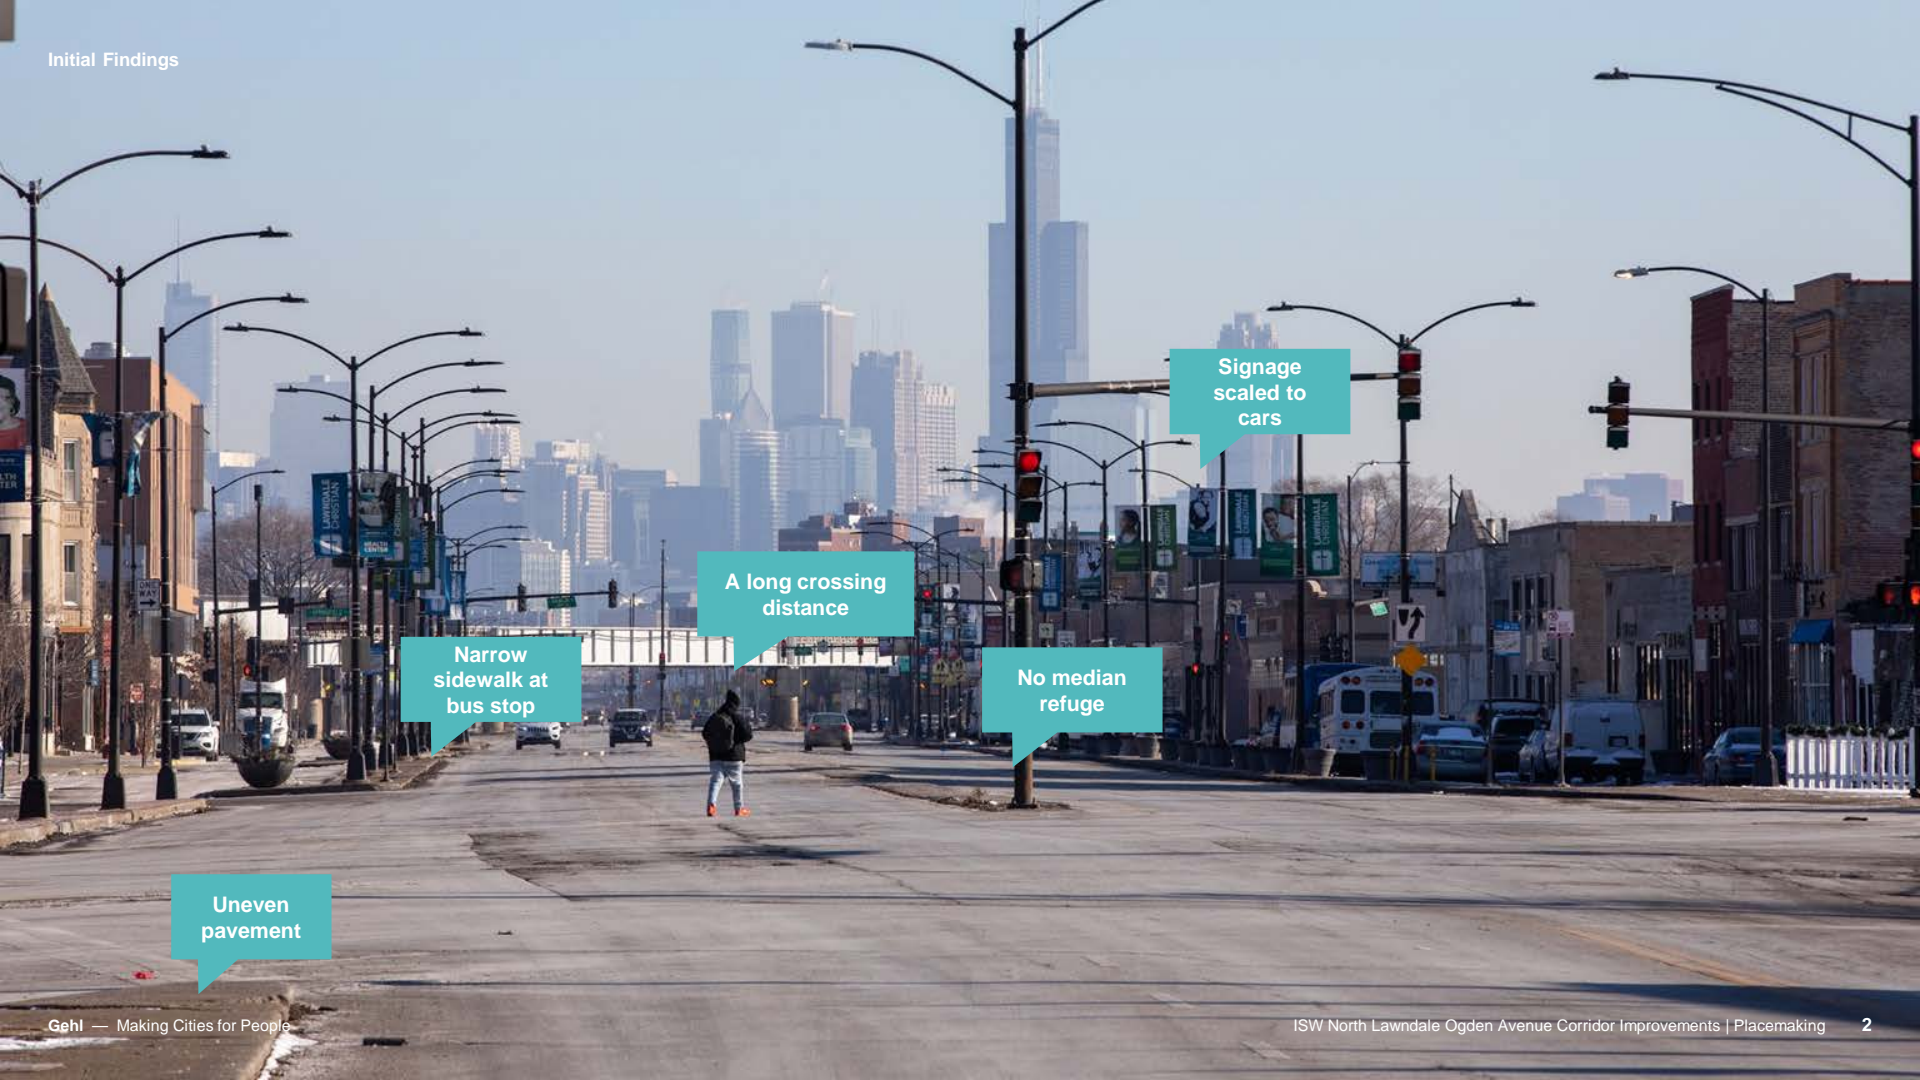
Uneven pavement

Narrow sidewalk at bus stop

A long crossing distance

No median refuge

Signage scaled to cars

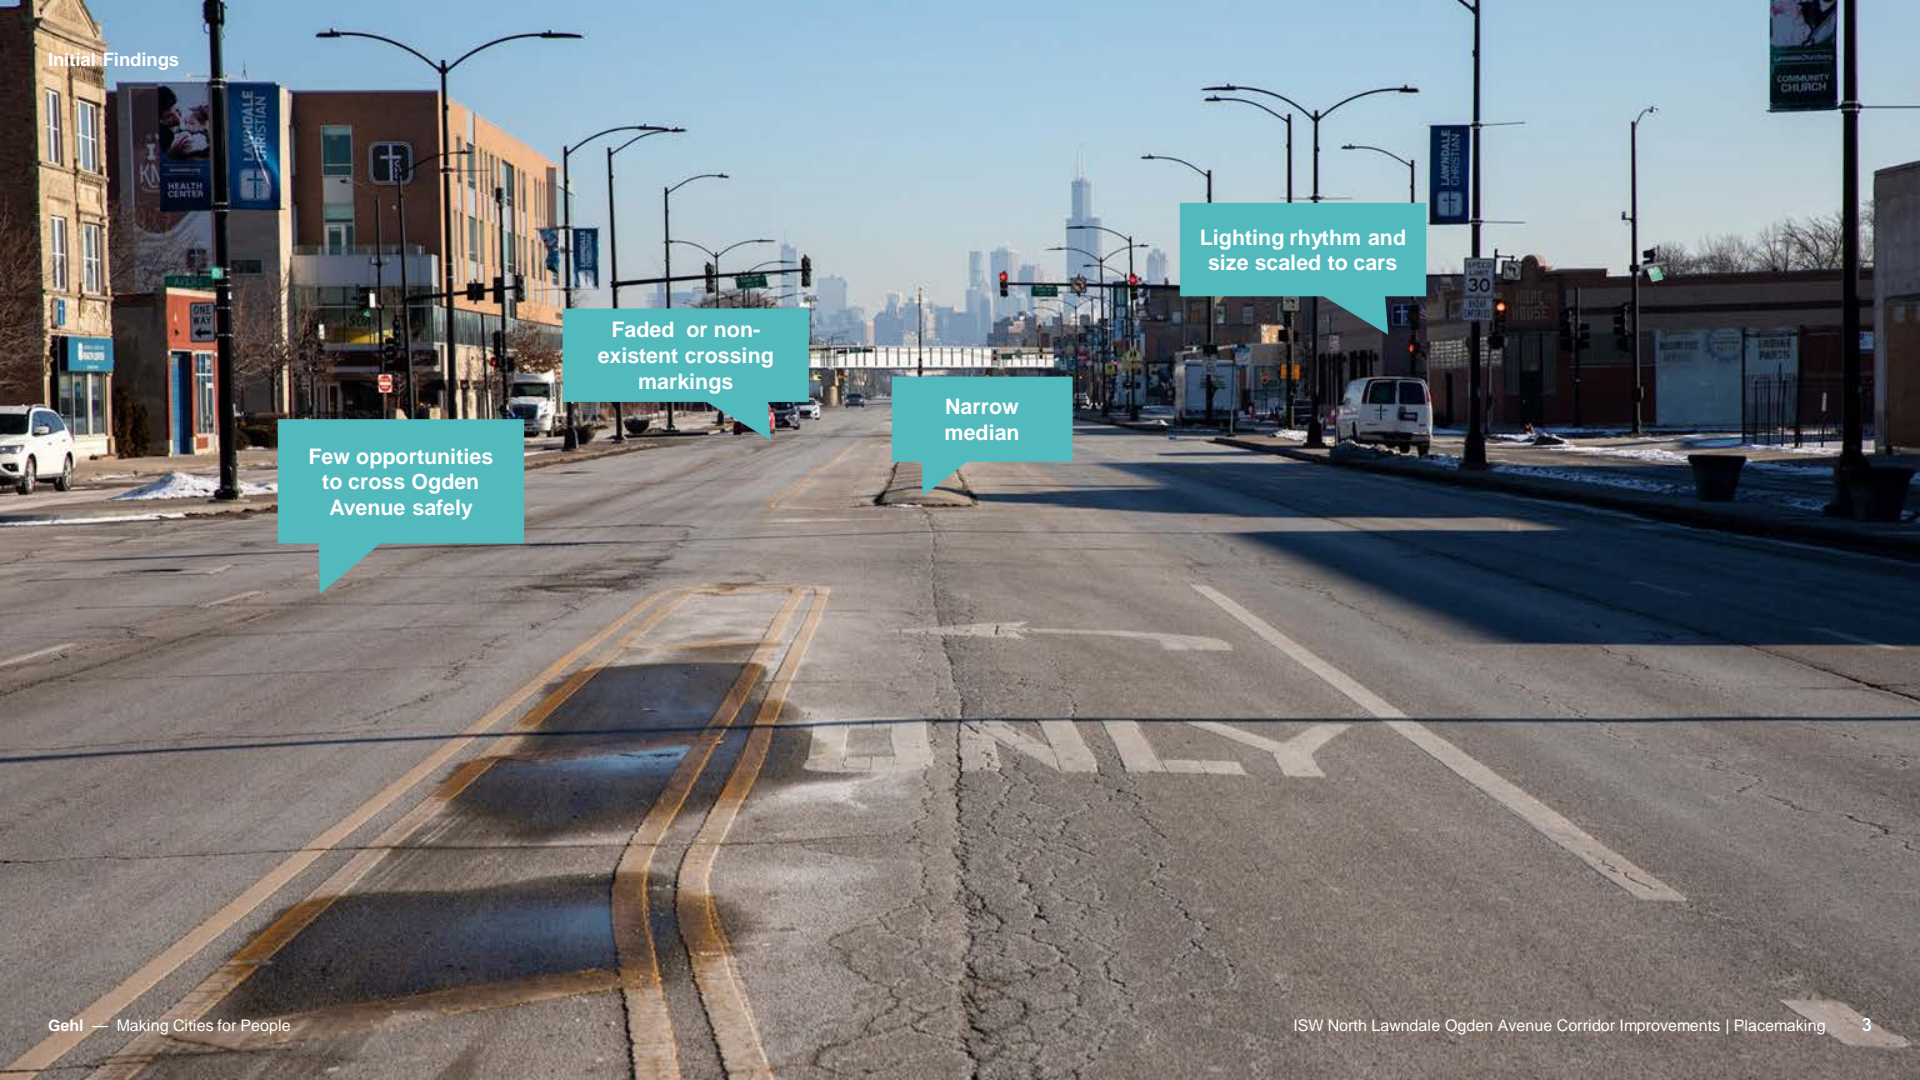
Few opportunities to cross Ogden Avenue safely

Faded or non-existent crossing markings

Narrow median

Lighting rhythm and size scaled to cars

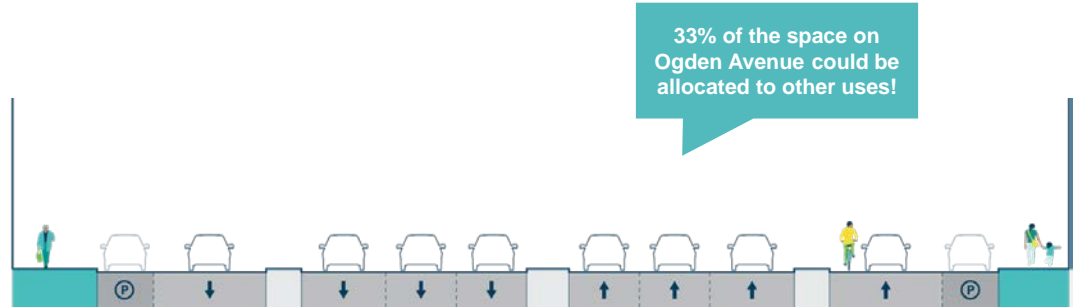
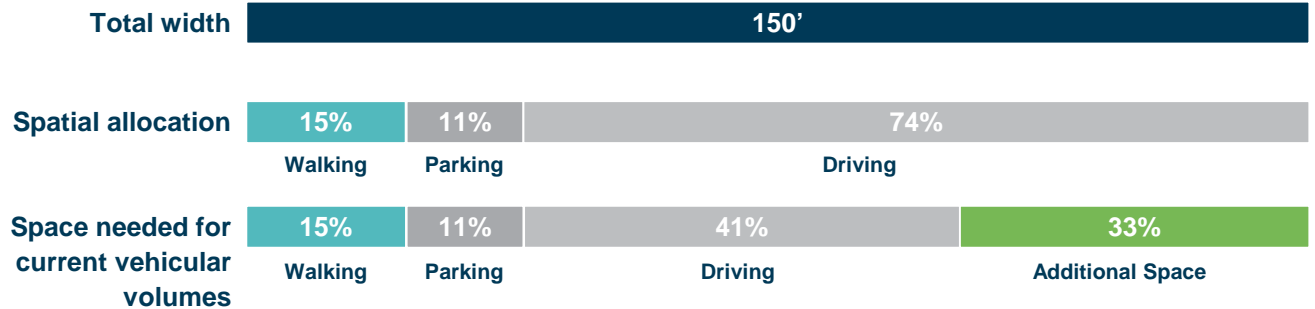
# Ogden Avenue has a configuration today that's extremely overbuilt...

There are up to 10 lanes of traffic built for less than 20,000 vehicles per day.

\*\* According to the Federal Highway Administration, the daily capacity for a 4-lane highway with left turn lanes is 31,000 vehicles.

...which provides an opportunity to improve safety for all.

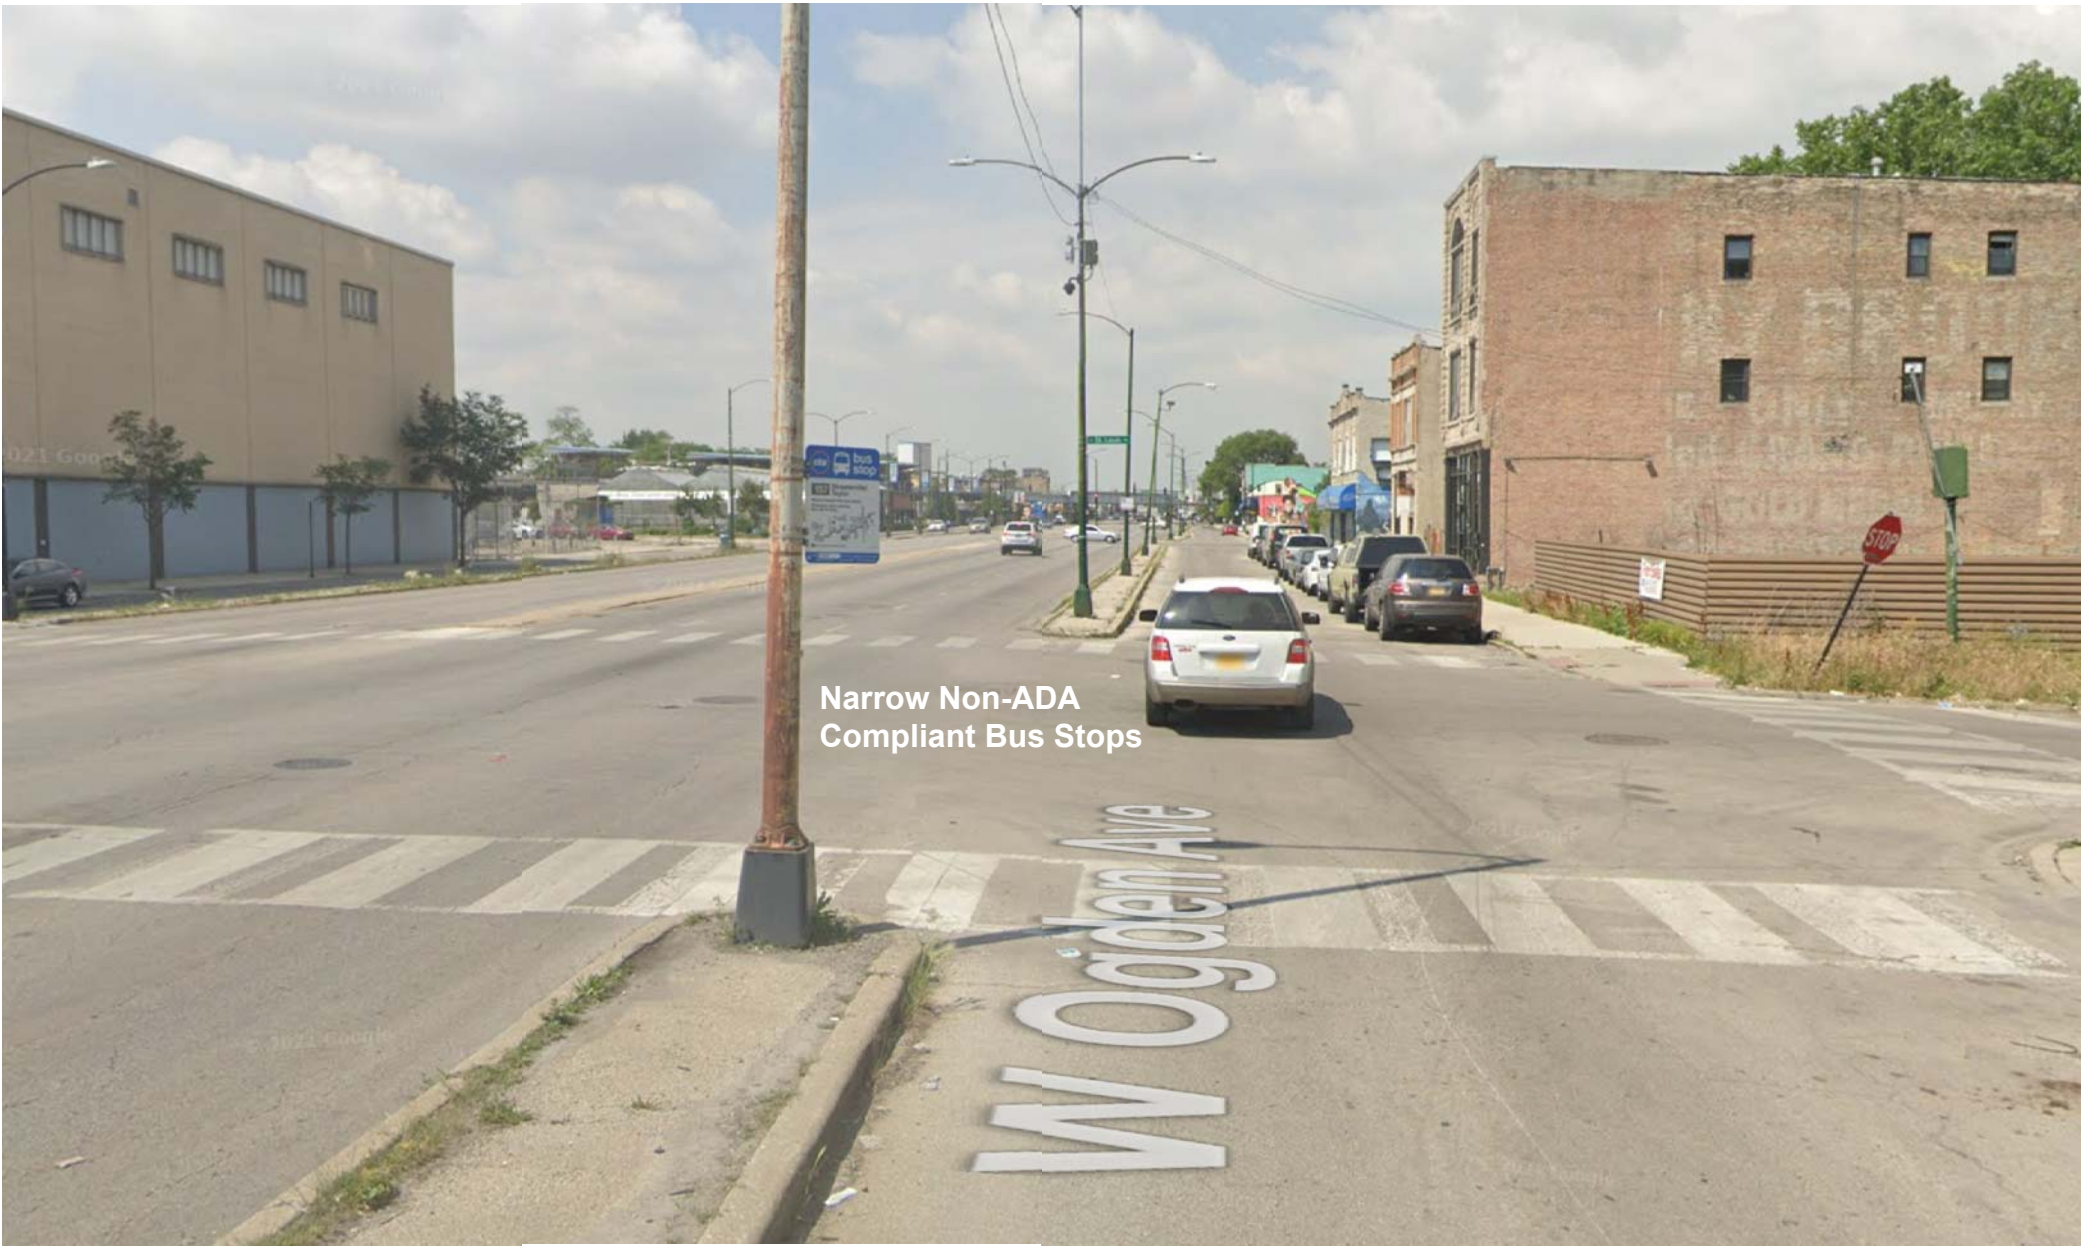
Narrow Non-ADA  
Compliant Bus Stops
